THE RUSTIC, HOUSTON DOWNTOWN

SAGE INCLUSION ASSESSMENT REPORT

Prepared JANUARY 2025

Assessment conducted by John Sage December 2024

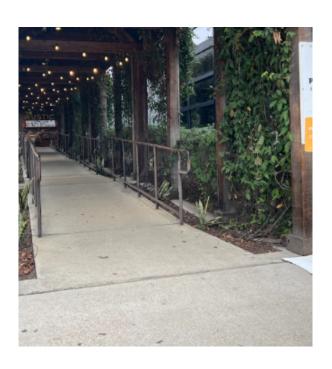
Parking and External Routes

- The pathways are wide with a minimum clear width of more than 36 inches along the path of travel
- The ground surface is stable, firm, and remains slip-resistant in both wet and dry conditions
- The ground surface visually contrasts with adjacent walls

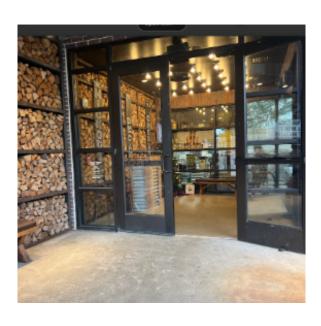
Entrance

- The entrance doors visually contrast with surroundings
- The double doorways provide sufficient width for guests using mobility aids
- The doors feature
 handles that allow for
 comfortable gripping
 from a seated or standing
 position
